REPORT NO. CG-D-8-77

FIELD TESTS OF IN-SERVICE MODIFICATIONS TO  
IMPROVE PERFORMANCE OF AN ICEBREAKER  
MAIN DIESEL ENGINE

AUGUST 1977

FINAL REPORT

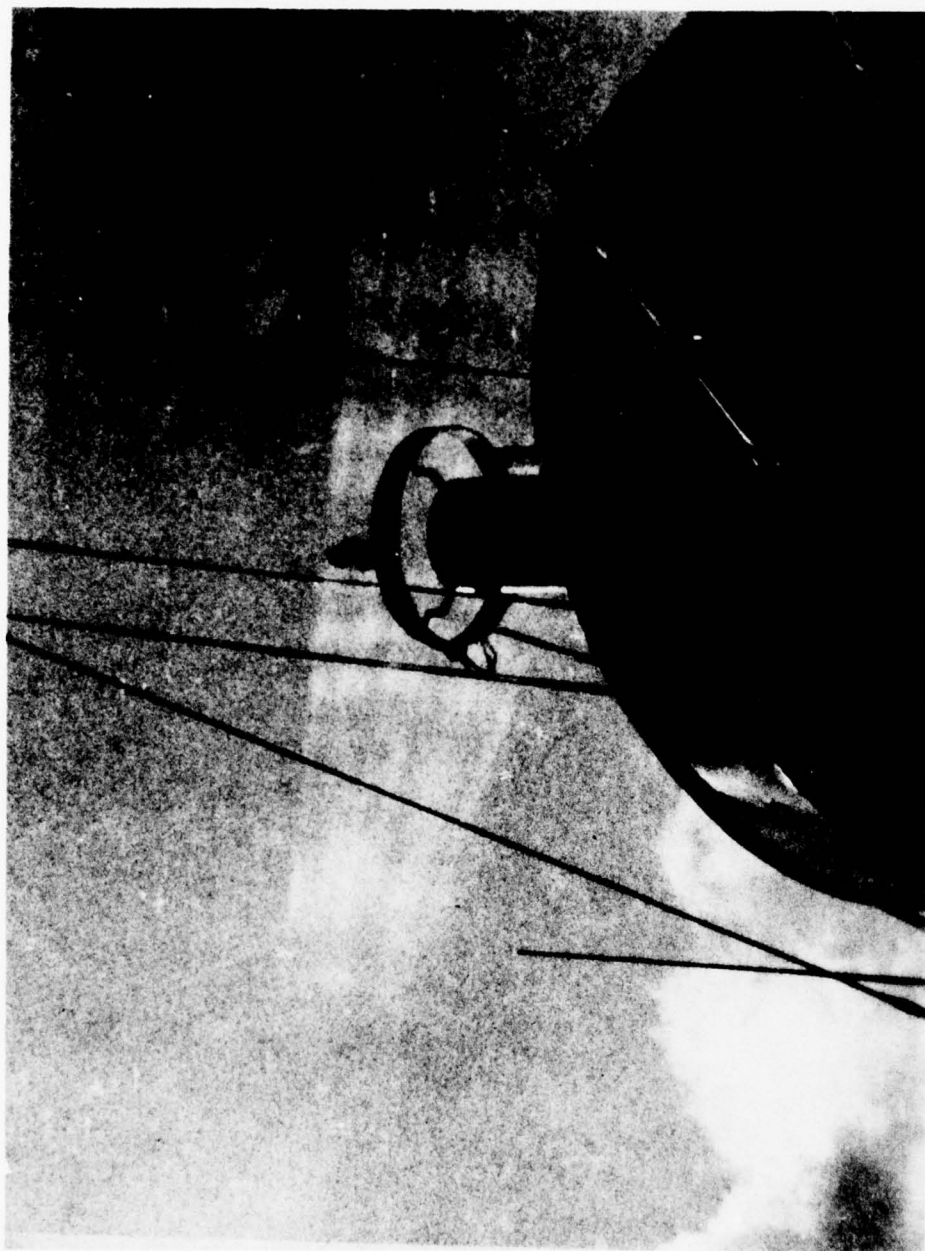
FIGURE 3. OPACITY METER

Two smoke meters were used for these tests. The first, the USPHS smoke meter, attaches to the top of the stack and is the recommended EPA diesel smoke measuring device. The second, an Atlantic Research Inc. in-line opacity meter measures the smoke density in the stack. Both of these meters work on the principle that light can be attenuated due to the absorption and scattering of the light by particulate matter in an optical medium such as stack gas. These meters have a light source, appropriate optics and a photo-detector. The stack gas is made to flow between the light source and detector. The major difference between the two smoke meters used here is that the USPHS meter has an incandescent bulb for a light source whereas the Atlantic meter uses a light-emitting diode (LED) for its source.

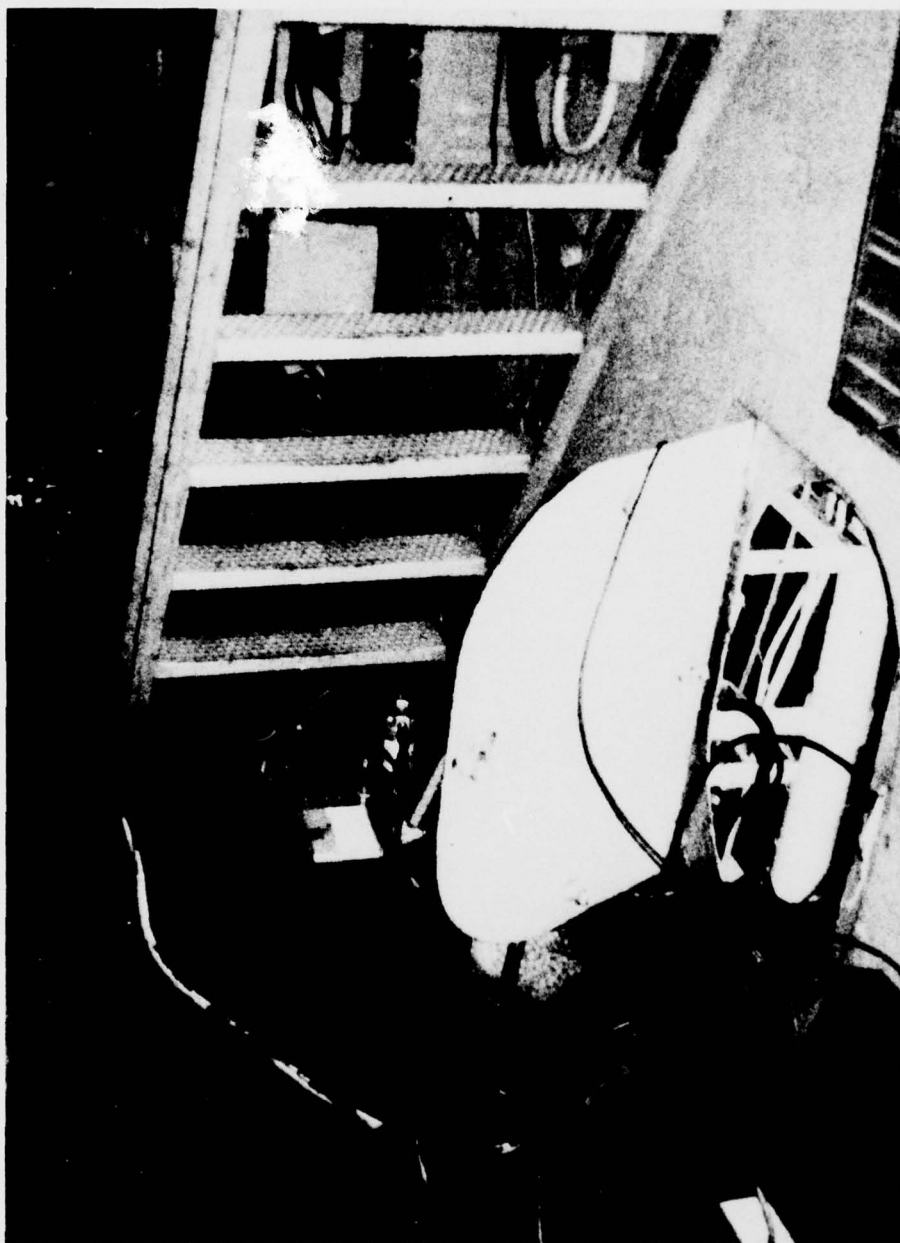
FIGURE 5. SMOKE METER CONTROLS
